**MEMORANDUM FOR DISTRIBUTION**

Enclosure (1) Report on the Collision between USS FITZGERALD (DDG 62) and Motor Vessel ACX CRYSTAL

Enclosure (2) Report on the Collision between USS JOHN S MCCAIN (DDG 56) and Motor Vessel ALNIC MC

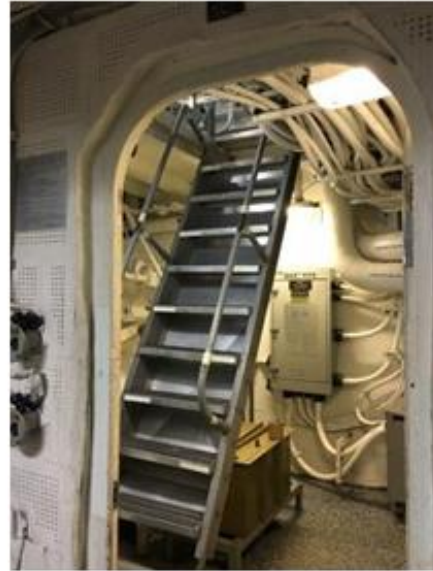
**Figure 9 – Non-watertight door frame from Berthing 2 to the ladder going up to Berthing 1 Access Trunk. There is no hatch at the top of this ladder to prevent water from flooding up into Berthing 1.**

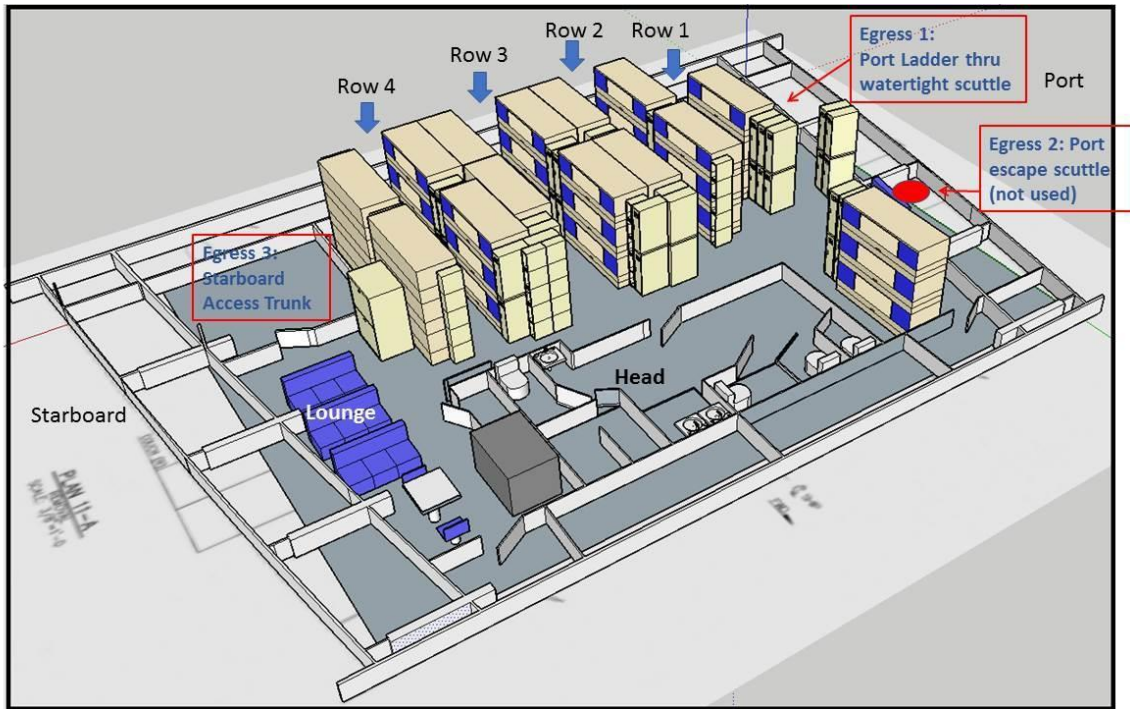
The flooding of Berthing 2 resulted in the deaths of seven FITZGERALD Sailors. The racks of these seven Sailors were located in Rows 3 and 4, the area closest to the starboard access trunk and egress point and directly in the path of the onrushing water, as depicted in Figure 15.

**Figure 15 – Berthing 2 Layout of Racks and Lockers (facing aft)**

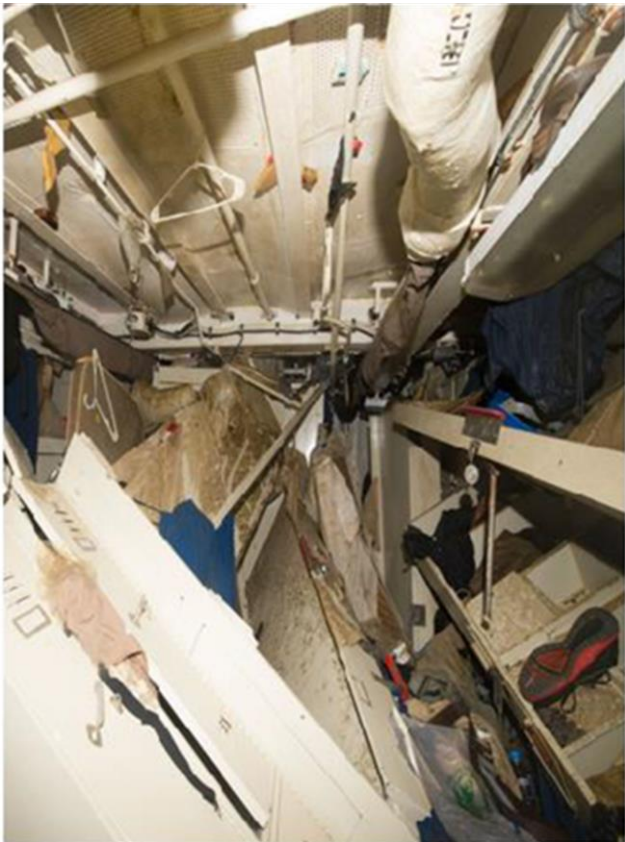
FITZGERALD Berthing 2 Racks Post-Deflooding

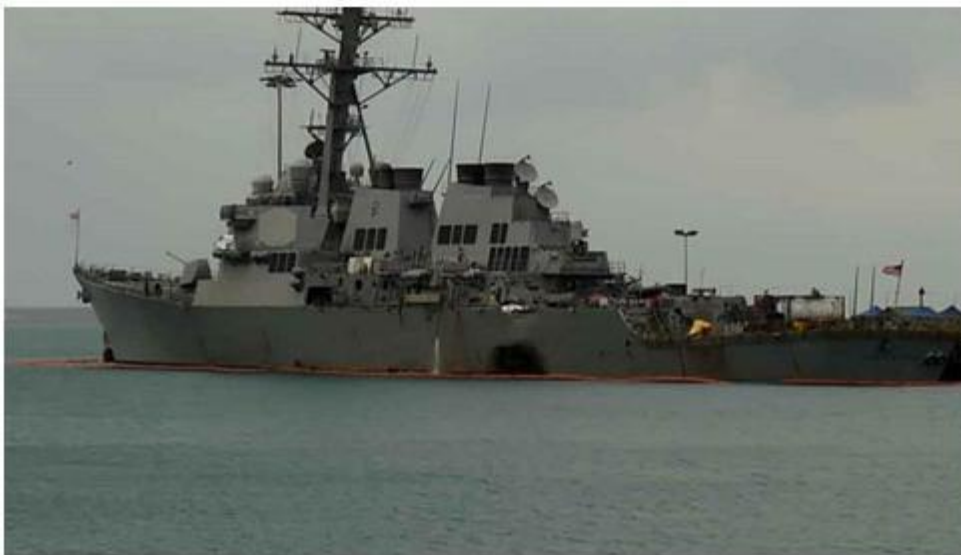
A team of Navy Divers arrived on JOHN S MCCAIN as the ship entered the harbor in Singapore at approximately 1200 on 21 August 2017. They began inspecting the ship to determine how best to proceed with a dive inside the ship. The leader of the dive team inspected Berthing 3 and saw waves breaking into the ship. The divers discovered the hole in the port side of JOHN S MCCAIN that was approximately 28 feet wide. See Figure 18.

**Figure 19 – Port side of JOHN S MCCAIN post-collision**

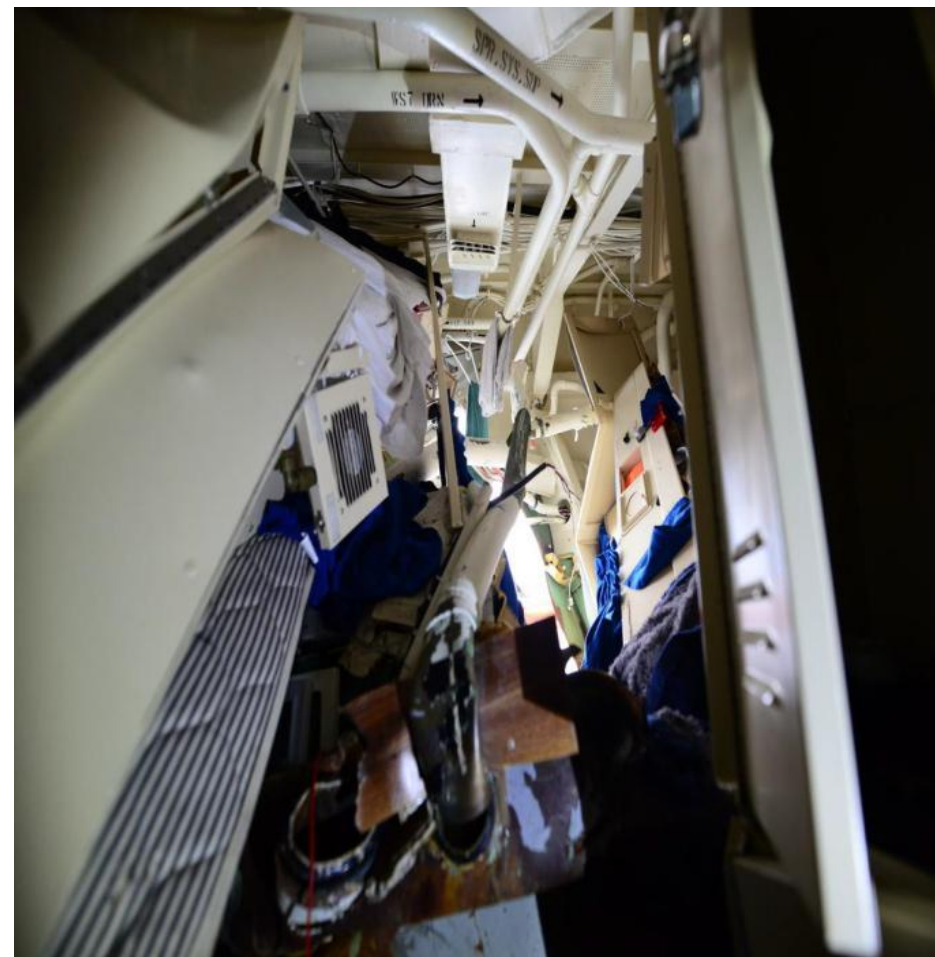
JOHN S MCCAIN, post-collision
