**MEMORANDUM FOR DISTRIBUTION**

Enclosure (1) Report on the Collision between USS FITZGERALD (DDG 62) and Motor Vessel ACX CRYSTAL

Enclosure (2) Report on the Collision between USS JOHN S MCCAIN (DDG 56) and Motor Vessel ALNIC MC

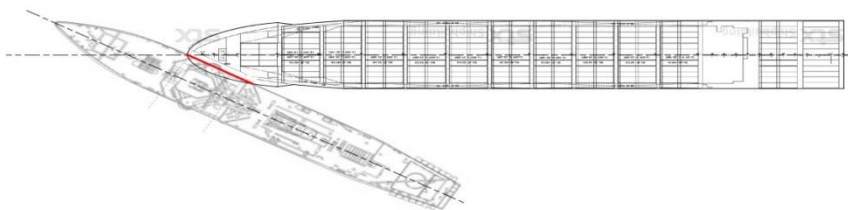
The port (left) side of CRYSTAL’s bow, near the top where the anchor hangs, struck FITZGERALD’s starboard (right) side above the waterline. CRYSTAL’s bulbous bow, under the water, struck FITZGERALD on the starboard side just forward of the middle part of the ship. CRYSTAL’s bulbous bow struck the starboard access trunk, an entry space that opens into Berthing 2 through a non-watertight door.

Figure 6 – Diagram of Approximate Collision Geometry

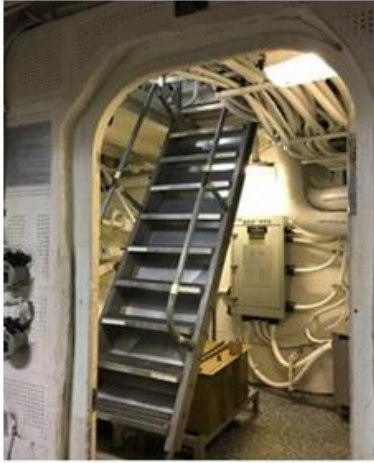
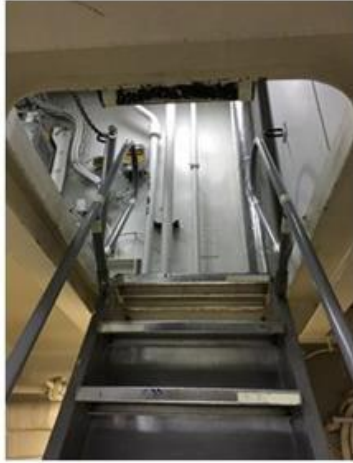
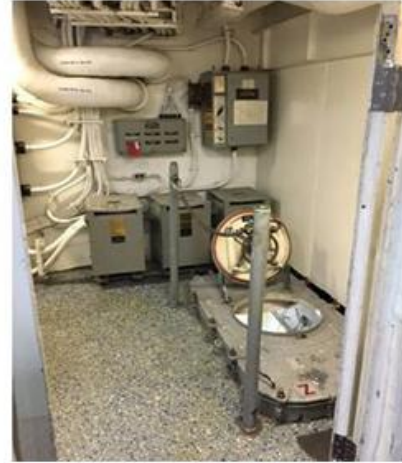
Figure 11 – Sample Berthing 2  
Starboard Side Egress – Ladder  
Up

Figure 12 – Sample Berthing 2  
Starboard Side Egress – Ladder  
Up

Figure 13 – Sample Berthing 2  
Starboard Side Egress – Scuttle  
Down to Forward IC (no outlet)

FITZGERALD. A non-watertight door leads from Berthing 2 to the starboard access trunk. In that trunk, a ladder leads up one deck into a space just outside of Berthing 1. Figures 11 through 13 are examples of the starboard side egress on a ship of the same class as FITZGERALD. There is no hatch separating the starboard access trunk outside Berthing 2 and the space above it. Also in this starboard access trunk is a hatch and watertight scuttle connected to a ladder going down to the Forward Interior Communications (FWD IC) space. FWD IC is not manned underway and has no other exits.

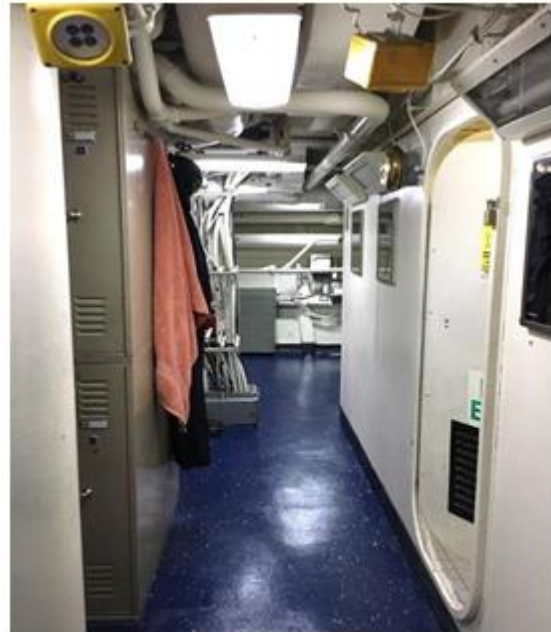
the starboard side to the port side. Many of the Sailors recall that the battle lanterns were illuminated. Battle lanterns turn on when power to an electrical circuit is out or when turned on manually. The yellow boxes hanging from the ceiling in Figure 14 are battle lanterns.

Sailors recall that after the initial shock, occupants lined up in a relatively calm and orderly manner to climb the port side ladder and exit through the port side watertight scuttle. Figure 14 provides an example of the route Sailors would have taken from their racks to the port side watertight scuttle on a ship of the same class as FITZGERALD. They moved along the blue floor and turned left at the end to access the ladder. Figure 14 provides an example and sense of scale. Even though the Sailors were up to their necks in water by that point, they moved forward slowly and assisted each other. One Sailor reported that FC1 Rehm pushed him out from under a falling locker. Two of the Sailors who already escaped from the main part of Berthing 2 stayed at the bottom of the ladder well (see Figure 8) in order to help their shipmates out of the berthing area.

Figure 14 – Sample Berthing 2 View from Row 3 of racks to the port side (open door on right leading to head)

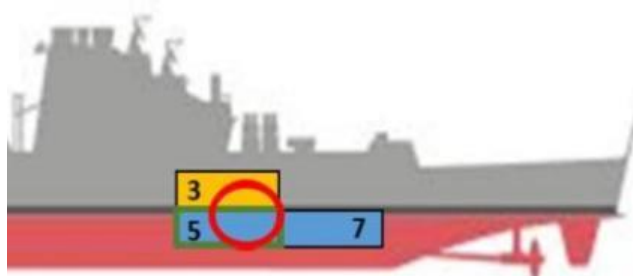
Berthing 5 is located aft (near the back of the ship) on the port side. See Figure 10. It is approximately 25 feet by 15 feet and has 18 racks, stacked as bunk beds three-high. Each row of racks has a locker for Sailors' belongings. There is a lounge with seats, a small table, and a wall-mounted television. There is a head with one toilet, one shower stall, and one sink.

**Figure 11 - Relative Positions of Berthings 3, 5 (in green), and 7, and point of impact**

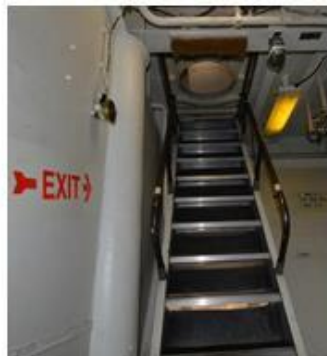
There are two means to exit Berthing 5: the primary egress (ladderwell) through a hatch with a scuttle (Figure 11) and an escape scuttle into Berthing 3 on the deck above (Figure 12).

**Figure 12 – Primary egress from Berthing 5**  
**Left: from within Berthing 5**  
**Right: Above on the deck outside Berthing 3**

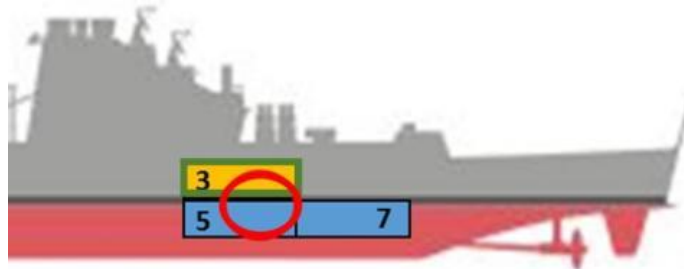
At 0530, the DCA began receiving reports of a ruptured fire main and water and fuel flooding into Berthing 3. The port side of Berthing 3 suffered substantial damage, including a large hole in the bulkhead. See Figure 13. Racks and lockers detached from the walls and were thrown about, leaving jagged metal throughout the space. Cables and debris hung from the ceiling.

**Figure 14 - Relative Positions of Berthings 3, 5, and 7 and point of impact**

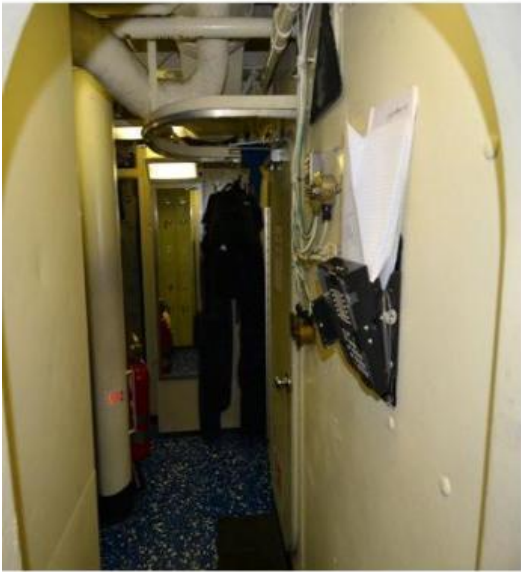
**Figure 15 – Berthing 3 facing port**

Hearing reports that Sailors were trapped in Berthing 3, the Executive Offer and a group of Sailors, including some who evacuated Berthing 7, went to check on their shipmates. Several Sailors were pinned in their racks as a result of the collision, but, as the two ships pulled apart, the twisted metal shifted and most of the Sailors in Berthing 3 were able to escape as the debris moved. One of these Sailors was pinned in his rack underneath two racks that had collapsed and a number of lockers that became dislodged during the collision. He was able to escape after ALNIC MC detached. See Figures 14 and 15.

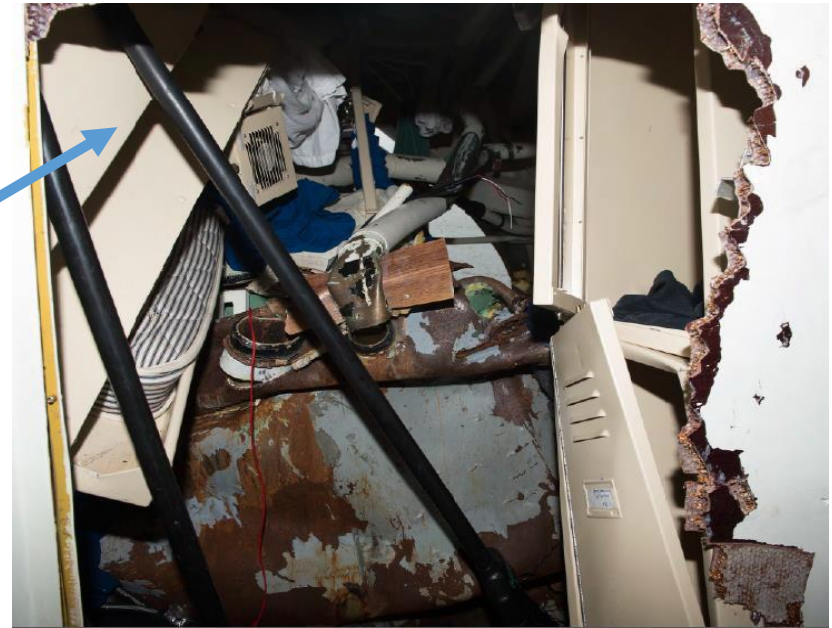
View through hole cut into bulkhead (wall)
